Manhole Inspection Summary

Manhole # S15AA1019MH

Location Address: **2624 VIOLET AVE**

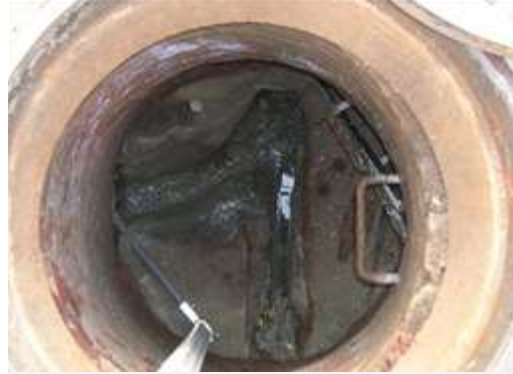
Top View

Corroded steps. Evidence of surcharge - Bench debris. Channel debris.

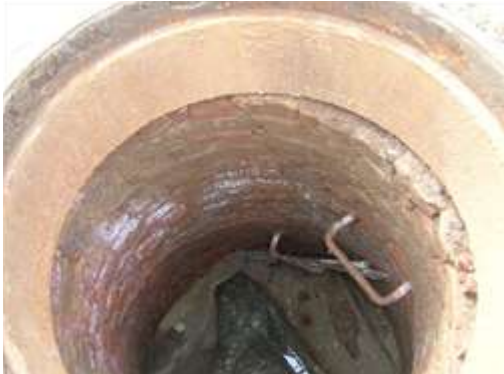
Defect

Frame leaks. Frame offset. Adjustment deterioration, loose brick and infiltration. Corbel and Barrel infiltration.

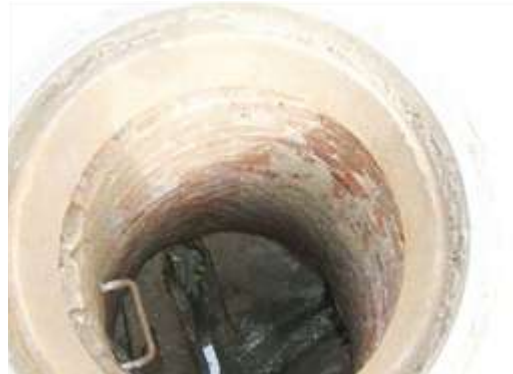
Defect

Frame leaks. Frame offset. Adjustment deterioration, loose brick and infiltration. Corbel and Barrel infiltration - other side.

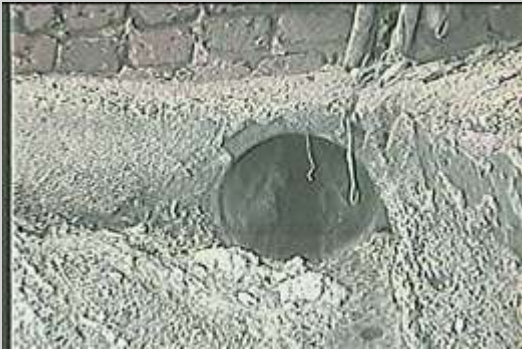
8 in. Circular Gravity Sewer Pipe Out @ 12 O'Clock

Deposits: ☐ None ☐ Mud ☐ Sludge ☒ Debris ☒ Grease

Infiltration: **Evidence** Pipe Seal Cond: **Roots**

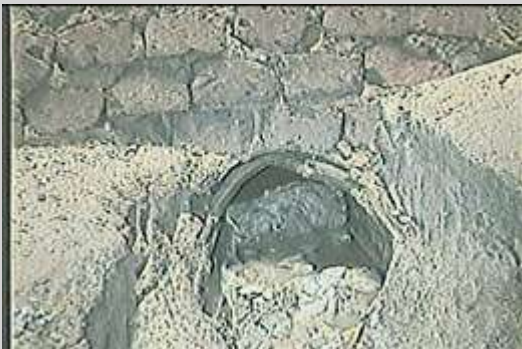
8 in. Circular Gravity Sewer Pipe In @ 6 O'Clock

Barrel deterioration and infiltration.

Deposits: ☐ None ☐ Mud ☐ Sludge ☒ Debris ☐ Grease

Infiltration: **Evidence** Pipe Seal Cond: **Broken**

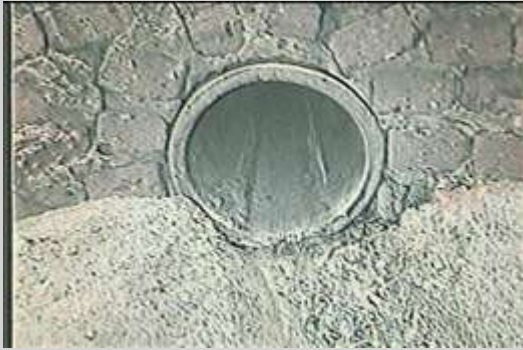
Pipe In @ 9 O'Clock

Infiltration: **Evidence**

Pipe Seal Cond: **Cracked**
